Potential Error of Pre-cooler Installation

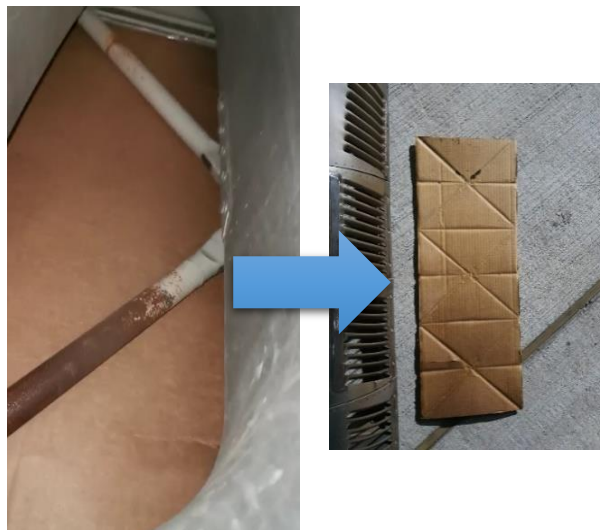
On February 8th, 2020, during troubleshooting of Engine #1 bleed air fault at Sta. MCT found pre-cooler inlet was blocked by cardboard packaging that was not removed during installation.

Due to bleed system problem, the rectification process need more time while the replacement parts arrived very late. Therefore, the maintenance crew perceived pressure during maintenance to avoid further delay and operation disruption.

Engineer as a supervisor did not fully ensure the inspection process to detect the cardboard before installation of precooler by Technician.

Pre-cooler replacement was performed at night outside hangar where the illumination was insufficient.

- Supervisor shall ensure preparation *before* installation process (tools & equipment, part / component, access, manpower) are available and meet the requirement of aircraft maintenance manual.

- Perform General Visual Inspection before installation of the part, ensure the part was identified completely and free from unwanted material.

- Do carefully step-by-step task of maintenance to deal with time pressure, ask colleague to manage rush during maintenance.

- Use proper illumination when it is dark condition, do not continue the work after there are sufficient light available.
