**SAFETY  
BRIEFING  
SHEET**

## Langkah Tepat Atasi *Intermittent Failure* Yang Mengakibatkan *LOTC/UHT* Pada B777

ENGINEERING INFORMATION		No.:	B9/73-000-0001/EI
A/C TYPE : Boeing 777		Date	13 August 2020
<b>Subject :</b> INBOUND CHECK OF ENG EEC C1 MAINTENANCE MESSAGES		Reff	SB 73-0117 R01
		Attn	TLH, TLC, TLD, TLG, TLS, TLM, TLK
		Effect	All Boeing 777-300 ER with GE90 engine
<b>Tech. Data Affected :-</b>			
<b>Distribution :</b> MQA, MQC, MQP, MQE, TLP, TEA, TEB, TEP, TCD		<b>Engineering Release:</b>

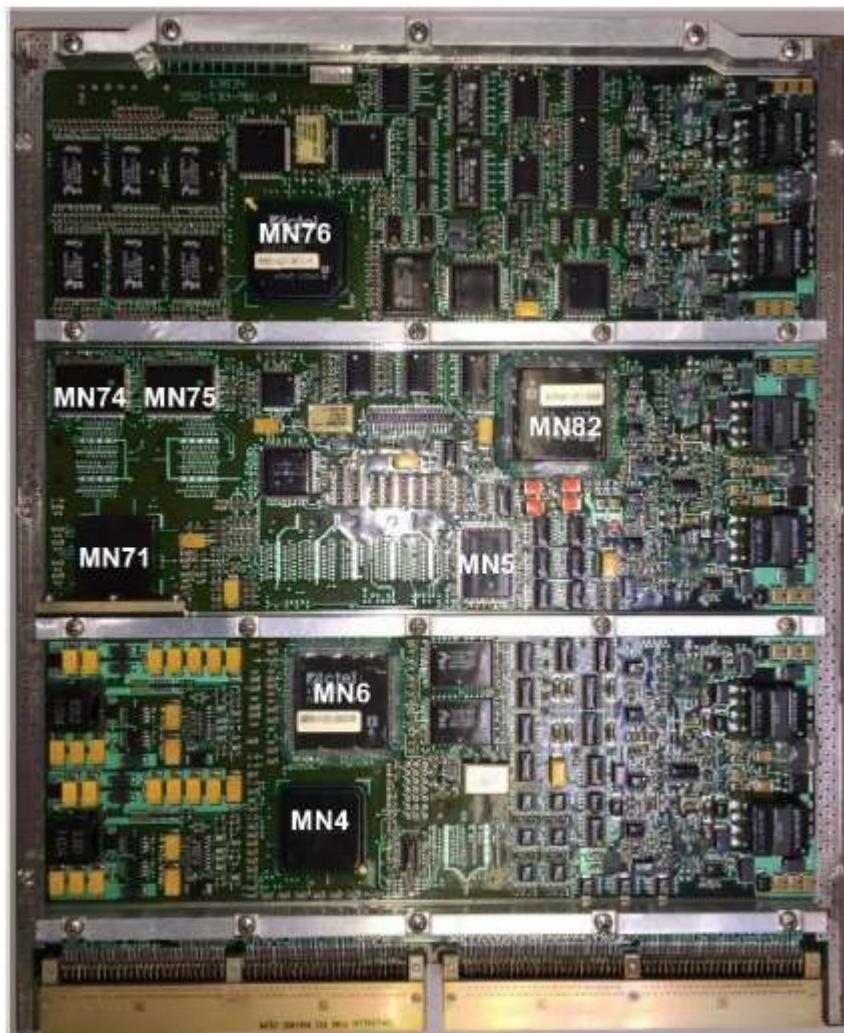
Picture 1. EEC electronic board, MN4 location

<b>REASON:</b> <p>In October 2019, an intermittent MN4 BGA solder ball failure occurred during descent resulting in a loss of thrust control (LOTC) / uncommanded high thrust (UHT). Intermittent failure resulted in an incorrect signal being used for throttle lever angle (TLA) value on Channel A. Selected TLA is normally the average of channel A and Channel B values. When Channel A and Channel B disagree by more than 2 degrees, the greater of Channel A and Channel B will be used for Selected TLA. This is by design to ensure engine will always meet thrust. The Channel A TLA value was greater than the Channel B TLA value, resulting in a higher Selected TLA.</p>

A FADEC solder ball joint failure initiated a system effect that resulted in a LOTC event. The LOTC event was preceded by a TLA and FMV resolver feedback faults one flight prior to the event.

All solder joints fatigue as a function of thermal cycles. A thermal cycle is accumulated during every flight as the solder joints heats and cool. The ambient temperature of the EEC on the ground ranges from - 40°C to 130°C. The ambient temperature of the EEC in the air during cruise is approximately - 65°C. The MN4 solder ball failure resulting in the UHT event occurred at 5,820 cycles.

ENGINEERING INFORMATION	No.:	10000157737/000/00
<u>Maintenance Recommendation</u>		
Perform this instructions if and when an ENG EEC C1 L or ENG EEC C1 R status message is present during normal pre-flight checks (prior to dispatch) as follow:		
<ol style="list-style-type: none"> <li>1. Use the maintenance access terminal (MAT) central maintenance computer function (CMCF) shop faults function to find the maintenance messages for each channel of the FADEC for the inbound flight leg. Refer to the GE90-100 Boeing 777 AMM, 45-10-00, MAINTENANCE PRACTICES, TASK 45-10-00-740-807, How to Find Shop Faults Data.             <ol style="list-style-type: none"> <li>a) Select ATA System 71-80 Left/Right Engine.</li> <li>b) Select LRU Name Electronic ENG Control (FADEC) (L/R Eng Ch A).</li> <li>c) Make a record of all maintenance messages in the Shop Faults List of Contents for the Flight Leg that corresponds with the ENG EEC C1 L or ENG EEC C1 R status message.</li> <li>d) Go back and select LRU Name Electronic ENG Control (FADEC) (L/R Eng Ch B).</li> <li>e) Make a record of all maintenance messages in the Shop Faults List of Contents for the Flight Leg that corresponds with the ENG EEC C1 L or ENG EEC C1 R status message.</li> <li>f) If there are 12 faults recorded in either channel for the Flight Leg that corresponds with the ENG EEC C1 L or ENG EEC C1 R status message, replace the FADEC prior to the next flight as follows:                     <ol style="list-style-type: none"> <li>1) Remove the FADEC. Refer to the GE90-100 Boeing 777 AMM, 73-21-15, REMOVAL/INSTALLATION, TASK 73-21-15-000-801-H01.</li> <li>2) Install the FADEC. Refer to the GE90-100 Boeing 777 AMM, 73-21-15, REMOVAL/INSTALLATION, TASK 73-21-15-400-801-H01.</li> </ol> </li> </ol> </li> <li>2. Use the MAT CMCF fault history function to find the maintenance message correlated with the ENG EEC C1 L or ENG EEC C1 R status message. Refer to the GE90-100 Boeing 777 AMM, 45-10-00, MAINTENANCE PRACTICES, TASK 45-10-00-740-816, How to Find a Maintenance Message Correlated to an Inbound Flight Deck Effect, make a record of all maintenance messages that correlate with ENG EEC C1 L/R, and do as follows:             <ol style="list-style-type: none"> <li>a) If there are no maintenance messages correlated with the ENG EEC C1 L or ENG EEC C1 R status message, replace the FADEC prior to the next flight as follows:                     <ol style="list-style-type: none"> <li>1) Remove the FADEC. Refer to the GE90-100 Boeing 777 AMM, 73-21-15, REMOVAL/INSTALLATION, TASK 73-21-15-000-801-H01.</li> <li>2) Install the FADEC. Refer to the GE90-100 Boeing 777 AMM, 73-21-15, REMOVAL/INSTALLATION, TASK 73-21-15-400-801-H01.</li> </ol> </li> </ol> </li> <li>3. Compare the maintenance messages recorded in steps 1. c), 1. e) and 2 with the conditions that follow:</li> </ol> <p style="text-align: center;"><b>NOTE: P = 1 or 2, where 1 = Left Engine and 2 = Right Engine</b></p>

4. If one of the conditions from step 3. Is present, replace the FADEC prior to the next flight as follows:
  - a. Remove the FADEC. Refer to the GE90-100 Boeing 777 AMM, 73-21-15, REMOVAL/INSTALLATION, TASK 73-21-15-000-801-H01.
  - b. Install the FADEC. Refer to the GE90-100 Boeing 777 AMM, 73-21-15, REMOVAL/INSTALLATION, TASK 73-21-15-400-801-H01.
5. If condition from step 3. Not present, continue troubleshoot maintenance message with related FIM task or insert to HIL refer to maximum operating time interval for C1 faults.
