Investigation Lesson Learn: Fuel Leak due to Packing not Installed

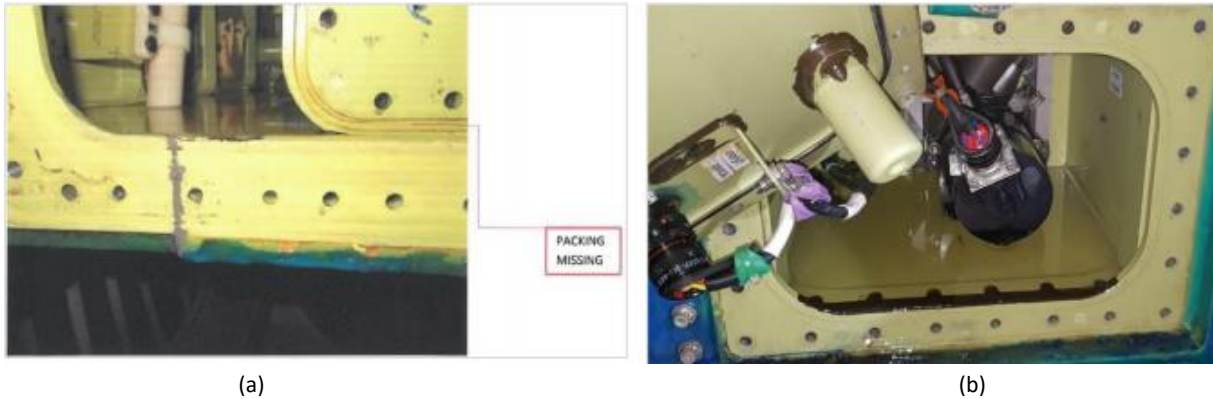
Few months ago, on June 2021, an Airline Internal Investigation reported an occurrence during heavy maintenance of an Airbus A-330 at the Maintenance Supplier. Fuel drops were found coming out of the aft drain mast of. The source of leak was identified from a great amount of fuel on the trim tank fuel pump compartment. Several fuel pump electrical wires were soak in fuel. Then, affected compartment was dried and trim tank was completely drained to find the source of leak. Finally, packing P/N MS9021-281 was found missing (see the picture). From the last maintenance record, it was known that there was no maintenance activity in that area for 2 years after the aircraft released from C-Check in a MRO.

(a) *Figure 1a. The Location Where Packing Should Be Installed*

(b) *Figure 1b. Amount of Fuel Inside the Trim Tank Transfer Pump Compartment*

After an in-depth investigation by the MRO, it was found that replacement of Packing Trim Tank has been performed by Mechanic on April 2019. On the same day, the Mechanic performed Installation of THS FS Center-Box-Access Panel 319DR Ref. AMM 55-11-14-420-054-B including install new packing to the trim tank transfer pump housing. Then, Engineer performed inspection with result no discrepancy was found.

At that time, required material has been provided in the PPC, including the packing. Based on the Material Shipping Document, Material Receiving Tag, and Transfer Order, the packing P/N AS3578-281 has been consumed for the task. In other side, the leak check of Trim Tank RH Fitting Rear Spar Connection has been performed by Mechanic and Engineer several days later with result no pressure decreased for 15 minutes.

Based on the occurrence above, it can be concluded that replacement packing P/N AS3578-281 was performed by Mechanic and Engineer and there was no discrepancy was found during installation. The leak check of Trim Tank RH Fitting Rear Spar Connection has been carried out by Mechanic and Engineer in accordance with AMM 55-11-14-720-050-A, but did not detect any failure.

1. **Make a well preparation** related to jobcard, maintenance manual, tools, and materials needed. Always **read and use updated maintenance manual or procedures** when doing your job. **Pay attention to Warning and Caution** to avoid accident / incident / aircraft damage.
2. Always **maintain the communication** between maintenance personnel or crew! **Use handover book** as a communication tool so no any job/task missed.
3. Be aware of the dangers of **distraction** while working! Repeat the previous 3 steps if you experienced it.
4. Perform **double check or double inspection** of the results of your job, even with fellow coworkers. Any deviations can be more easily captured.
