Pastikan Penggunaan *Serviceable Gasket* pada *Pressurization System*

Referensi: Safety Circular JKTMQ-SC-70009-2021

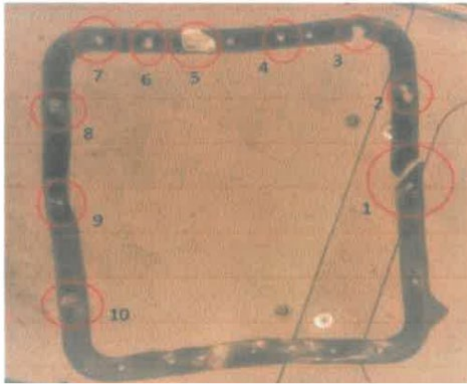
Figure 1. Damage FWD Outflow Valve Gasket of PK-GPF

Terdapat kejadian *Loss of Cabin Pressure* pada pesawat Airbus A330 Garuda Indonesia dengan registrasi PK-GPF sebagai GA-972 sector BTJ-JED tanggal 2 April 2019 saat melintasi Sri Lanka pada FL 380, sehingga PIC memutuskan untuk melakukan pendaratan darurat di *Bandaranaike International Airport* (BIA).

Sebelum terjadi *event* tersebut, pada tanggal 1 April 2019 dilakukan penggantian *Forward Outflow Valve Gasket* di *station* DPS sebagai tindak lanjut *repetitive PIREPs on CAB PR SYS 1 FAULT*.

Hasil Investigasi menunjukkan bahwa kegagalan *Pressurization System* pada PK-GPF disebabkan *leaks through seriously damaged gasket* seperti yang terlihat di *figure 1*.

1. Selalu membaca, memahami, mematuhi dan melaksanakan *Cautions, Warnings, dan Notes* seperti yang disebutkan dalam *Aircraft Maintenance Manual (AMM)*.
2. Tidak menggunakan *gasket* atau *seal* yang rusak/*damage*/kotor saat pelaksanaan *maintenance*.
3. Mematuhi AMM 21-31-51-000-801-A Subtask 21-31-51-020-050-A: ***Make sure that you do not damage the gasket*** pada saat melakukan penggantian *outflow valve*
