Safety Briefing Sheet:

KENALI PENYEBAB FUEL LEAK DI UNDERWING TANK ACCESS PANEL

WING FUEL ACCESS PANEL SEALING RING DAMAGE

Reference: 57.20.00.024

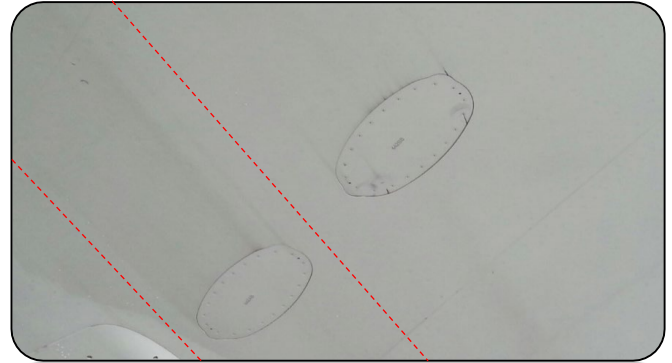
Gambar 1. Ilustrasi streaked black marks sebagai indikasi fuel leak pada fuel access panel

Mengacu pada *Airbus Technical Follow-Up* (TFU) 57.20.00.024, ketika ditemukan tanda hitam bergaris (*streaked black marks*) di sekitar *underwing tank access panel*, menunjukkan ada indikasi degradasi pada *seal ring*. Tergantung dari lokasi kebocoran *fuel*, kondisi tersebut dapat mengakibatkan situasi AOG dan akan mengganggu operasional. Dalam kebanyakan kasus, ditemukan kondisi *seal* yang sudah rusak, sementara pada beberapa pesawat, terdapat *access panel screw* yang telah hilang atau karena *screw overtorqued*. *Seal ring* harus segera diganti pada kesempatan pertama bergantung pada tingkat kebocorannya. Berikut beberapa *summary maintenance tips* berdasarkan referensi *AMM 57-27-11* yang dapat dilakukan oleh *maintenance personnel* untuk memperbaiki kebocoran pada *fuel access panel* :

1. Mengganti *seal* dengan yang baru sebelum memasang *underwing tank access panel*
2. Gunakan *specific sealant* sesuai ketentuan untuk mengikat *seal* baru ke *underwing tank access panel*
3. Oleskan *grease* pada *seal* sebelum pemasangan *underwing tank access panel*
4. Implementasikan urutan *cross diagonal torque sequence* seperti yang di ilustrasikan pada AMM

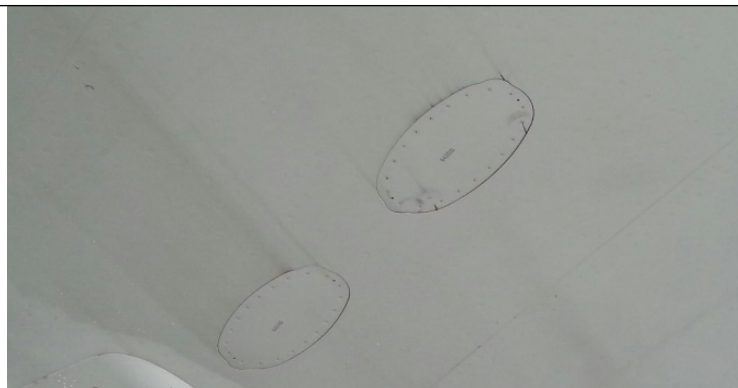
Operators have reported fuel leak on wing fuel access panels between RIB 01 and RIB 27 (non-load carrying panels).

When streaked black marks are found around access panel, it shows the sealing ring degradation.

Depending on the fuel leak location this could lead to an AOG situation.

In most cases, the sealing ring (ref IPC 57-27-11 fig 1 to 6 , pre-mod47583 (SPF) item 20 or post-mod47583 (alu machined) item 10 was found damaged

Depending of the importance of the level of the leak, the sealing ring has to be changed immediately or at the next Maintenance opportunity.

MOD 57909 is the terminating action with the new sealing ring material.

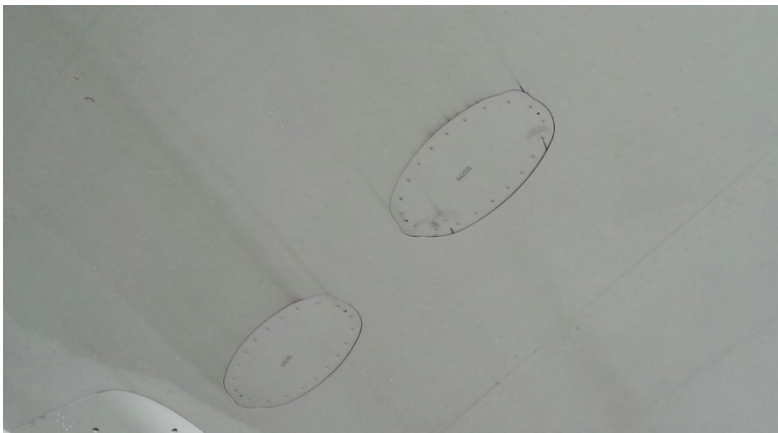
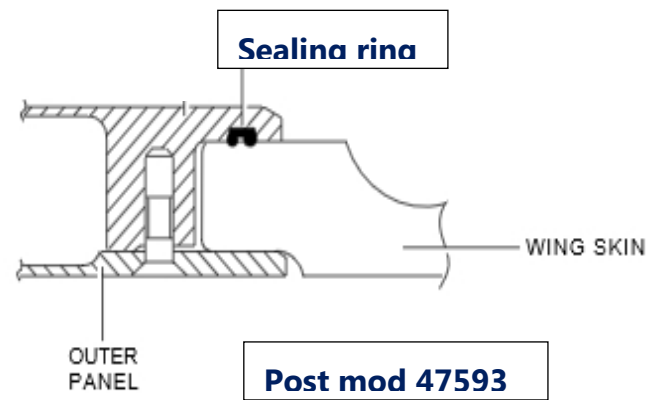
Typical finding

When streaked black marks are found around access panel, it shows the sealing ring degradation.

On some aircraft, missing access panels' screws or screws over torqued have been noticed.

Several parameters have been identified as having a major influence on access panel's fuel leaks:

- 1) Torque sequence installation procedure introduced into the AMM (cross diagonal pattern) shows to be more efficient as it maintains the sealing ring into its groove.
- 2) Seal shape Post mod 47583 has been reviewed with a more robust design and material changed to improve low temperature, performance and resistance to known contaminants.
- 3) Specific sealant to bond this new seal onto the access panels.

The sealing ring REF/D or REF /E has to be replaced.

Depending of the importance of the level of the leak, the sealing ring has to be changed immediately or at the next Maintenance opportunity.

The following instructions presented in AMM 57-27-11 fixed the leak:

- Replacement of the seal with a new one before panel installation
- bonding of the new seal on the panel
- apply grease on the seal before installation of the panel
- observe carefully the cross diagonal torqueing sequence as illustrated in the AMM
