Safety Briefing Sheet:

A320 ELT Antenna Missing, Apakah Penyebabnya?

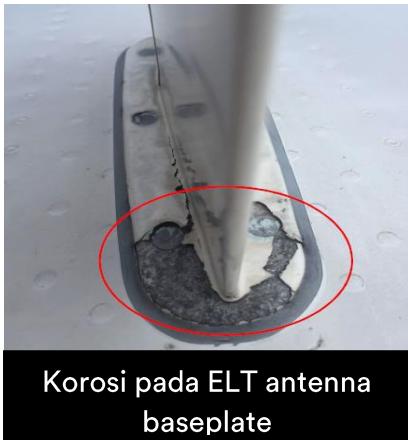
Ref. Fig. ELT Antenna

Beberapa pesawat A320 dilaporkan mengalami *ELT Antenna missing* yang berdampak pada operational pesawat tersebut. Root cause berdasarkan hasil investigasi oleh Airbus yang tertuang dalam TFU 25.65.00043, disebabkan adanya retakan pada *painting* yang memungkinkan *moisture* masuk hingga *baseplate* dari *antenna* sehingga dapat menimbulkan korosi. Ketika terjadi korosi di area *baseplate* dimana tempat *antenna blade* direkatkan, lem akan rusak dan *antenna blade* dapat terlepas dari *baseplate*.

- (1) Do a GVI of the external ELT antenna (1) and make sure that:
 - There are no blisters, bubbles and erosion on the paint.
 - There is no corrosion.
 - There are no cracks on the paint and on the aircraft structure around the external ELT antenna (1).
 - There are no signs of lightning strike.
 - There are no signs of damage on the junction between the base plate and the blade.
 - There are no signs of damage around the interface surfaces of the external ELT antenna (1) and the aircraft structure.
- (2) If you find signs of damage:
 - On the junction between the base plate and the blade of the external ELT antenna (1), and /or
 - Around the interface surfaces of the external ELT antenna (1) and the aircraft structure, replace the external ELT antenna (1) Ref. AMM TASK 25-65-14-000-001 and Ref. AMM TASK 25-65-14-400-001.
