**SAFETY  
BRIEFING  
SHEET**

## Langkah Tepat Atasi *Intermittent Failure* Yang Mengakibatkan *LOTC/UHT* Pada B777

ENGINEERING INFORMATION		No.:	B9/73-000-0001/EI
A/C TYPE : Boeing 777		Date	13 August 2020
<b>Subject :</b> INBOUND CHECK OF ENG EEC C1 MAINTENANCE MESSAGES		Reff	SB 73-0117 R01
		Attn	TLH, TLC, TLD, TLG, TLS, TLM, TLK
		Effect	All Boeing 777-300 ER with GE90 engine
<b>Tech. Data Affected :-</b>			
<b>Distribution :</b> MQA, MQC, MQP, MQE, TLP, TEA, TEB, TEP, TCD		<b>Engineering Release:</b>

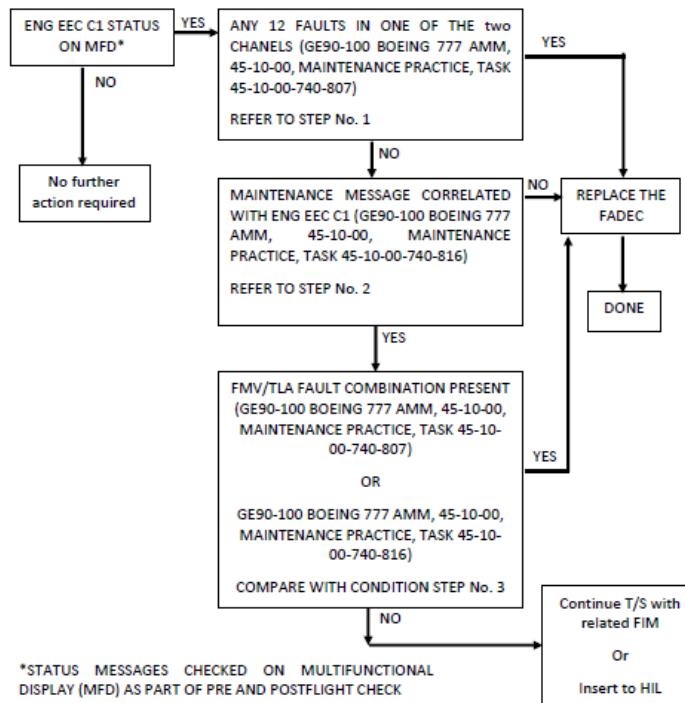
- d. Catat semua *maintenance message* yang ditemukan. Jika terdapat kombinasi dari ***maintenance message*** sesuai dengan list nomor 2c diatas, atau tidak terdapat *maintenance message* yang berhubungan dengan EEC C1 maka lakukan penggantian EEC sebelum keberangkatan pesawat.
- 3. Jika step 2a sampai dengan 2d telah selesai dilakukan dan tidak terdapat penggantian EEC yang disebabkan oleh step 2a sampai dengan 2d, maka *troubleshoot* dilanjutkan dengan penggeraan FIM yang berhubungan dengan *maintenance message* yang ditemukan pada point 2b dan 2d.
- 4. Dan jika waktu penggeraan step ke 3 tidak memungkinkan, maka pesawat dapat diberangkatkan dengan menggunakan referensi MEL yang berhubungan dengan *maintenance message* tersebut

Note: Untuk penanganan ***message ENG EEC C1*** juga dapat menggunakan referensi **FIM 73-98 TASKS 805**.

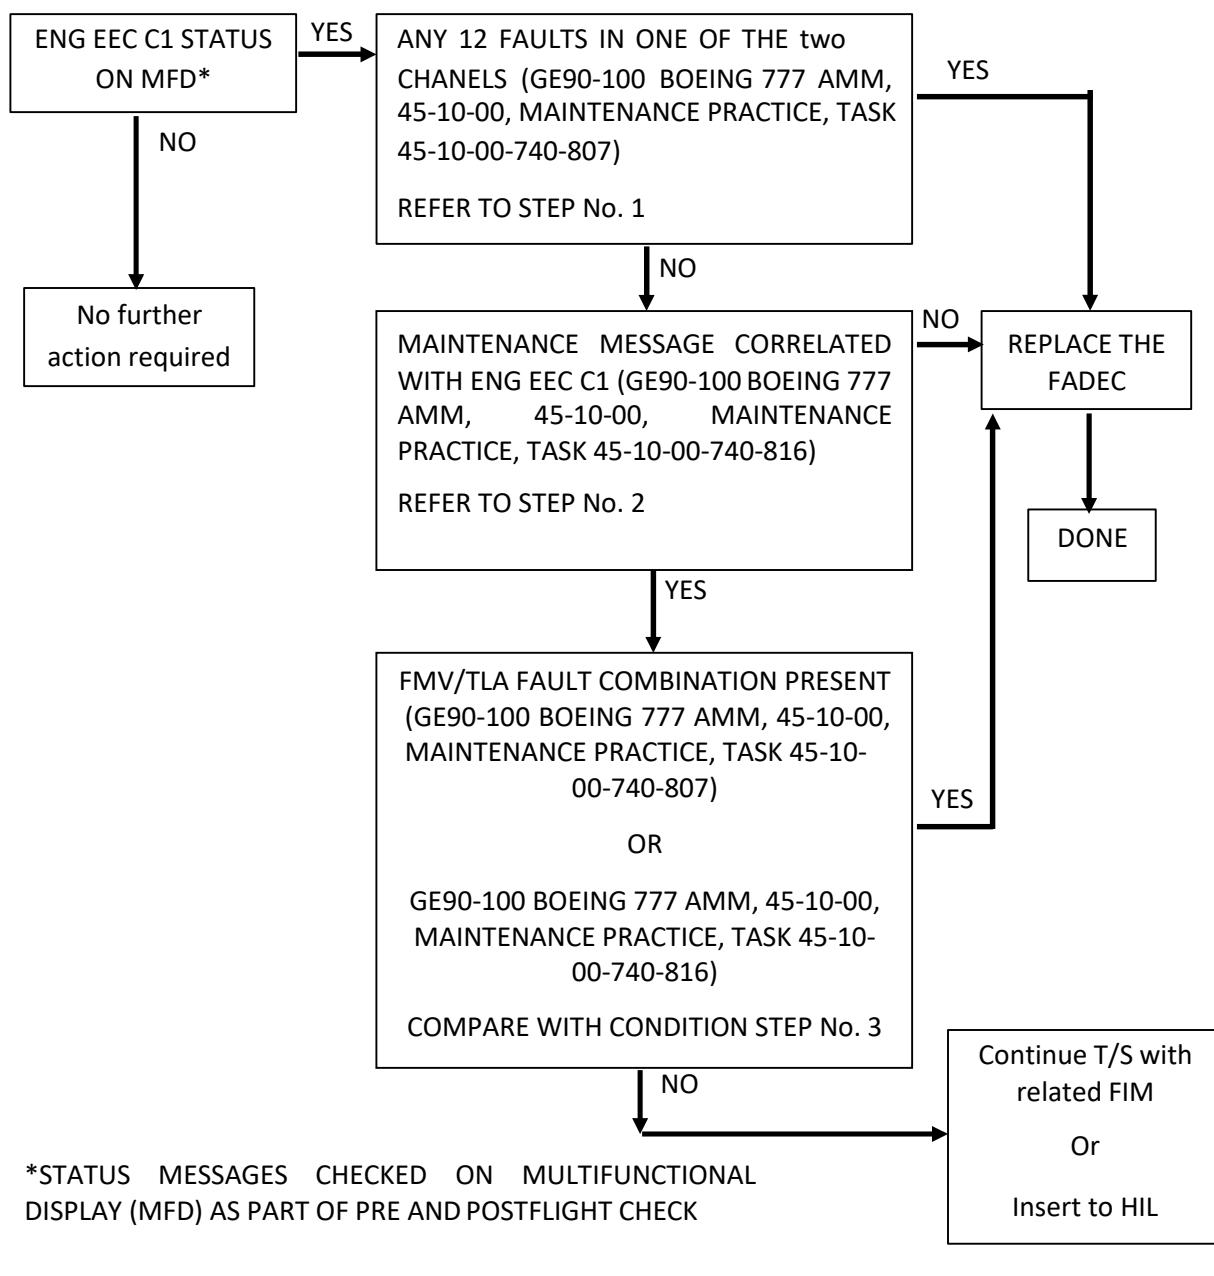
Condition	Maintenance Message Combination	Comments
FMV Disagree Fault	(73-1439P or 73-2439P) and (76-3520P or 76-1521P or 76-2521P)	FMV disagree fault on one of the two channels and any TLA range or disagree on one of the two channels
TLA Disagree Fault	76-3520P and (73-1325P or 73-2325P or 73-1439P or 73-2439P)	TLA disagree fault on one of the two channels and any FMV range or disagree fault on one of the two channels
Range Faults	(76-1521P and 73-1325P) or (76-2521P and 73-2325P)	FMV and TLA range faults on the same channel

4. If one of the conditions from step 3. Is present, replace the FADEC prior to the next flight as follows:
  - a. Remove the FADEC. Refer to the GE90-100 Boeing 777 AMM, 73-21-15, REMOVAL/INSTALLATION, TASK 73-21-15-000-801-H01.
  - b. Install the FADEC. Refer to the GE90-100 Boeing 777 AMM, 73-21-15, REMOVAL/INSTALLATION, TASK 73-21-15-400-801-H01.
5. If condition from step 3. Not present, continue troubleshoot maintenance message with related FIM task or insert to HIL refer to maximum operating time interval for C1 faults.
